Bedlington Old School
Front Street West, Bedlington
Northumberland
NZ 426015 581860

Archaeological Building Recording
for

Dysart Developments Ltd

109-14-HS | December 2014

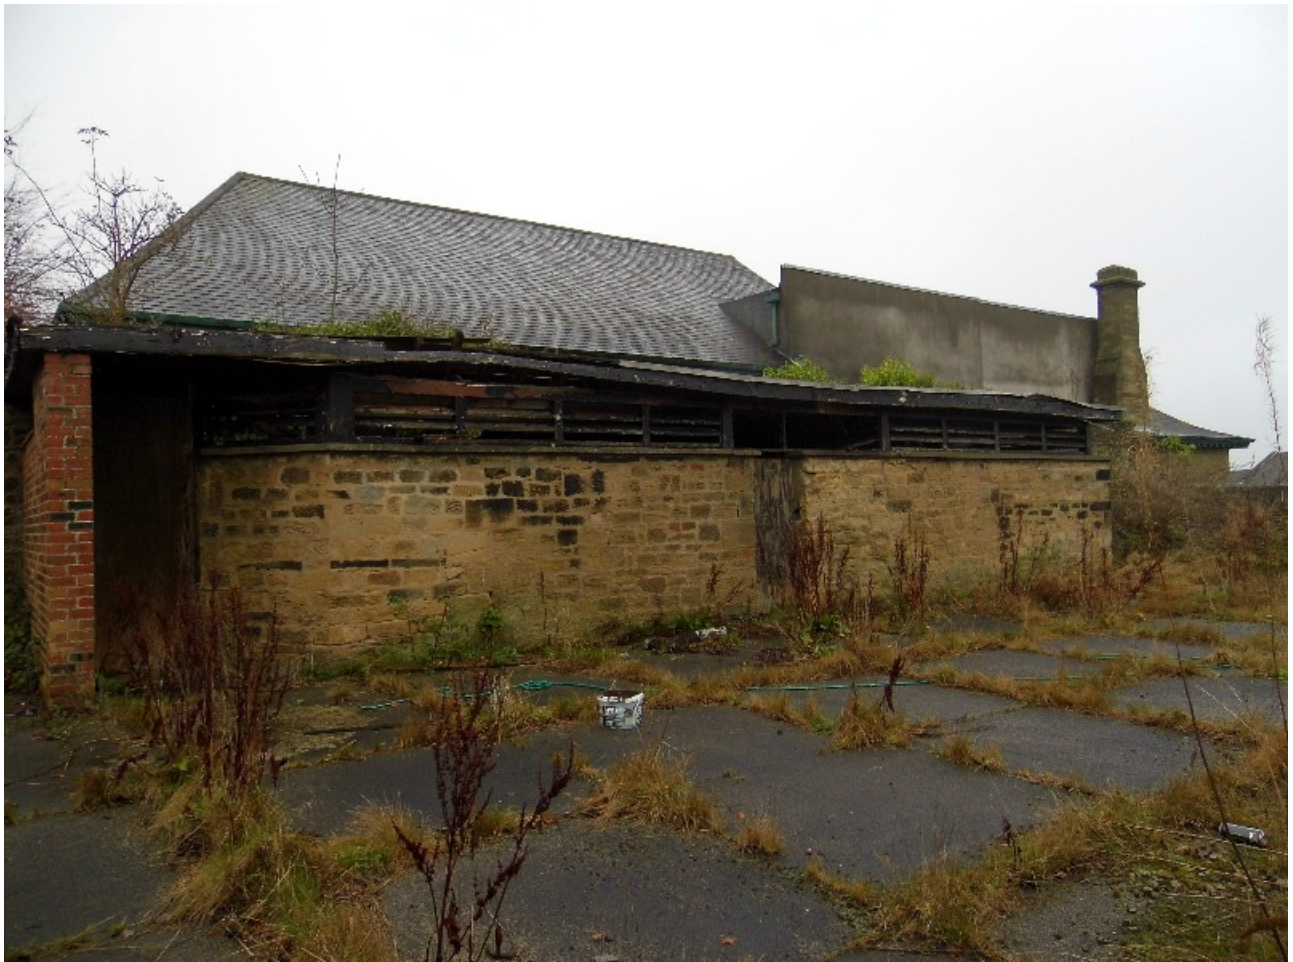
Plate 2. The outbuilding looking northwest (frame BOS14003)

sustained a great deal of external damage due to fire and ivy ingress. The original structure also sports a shallow stone plinth at the base of the walls.

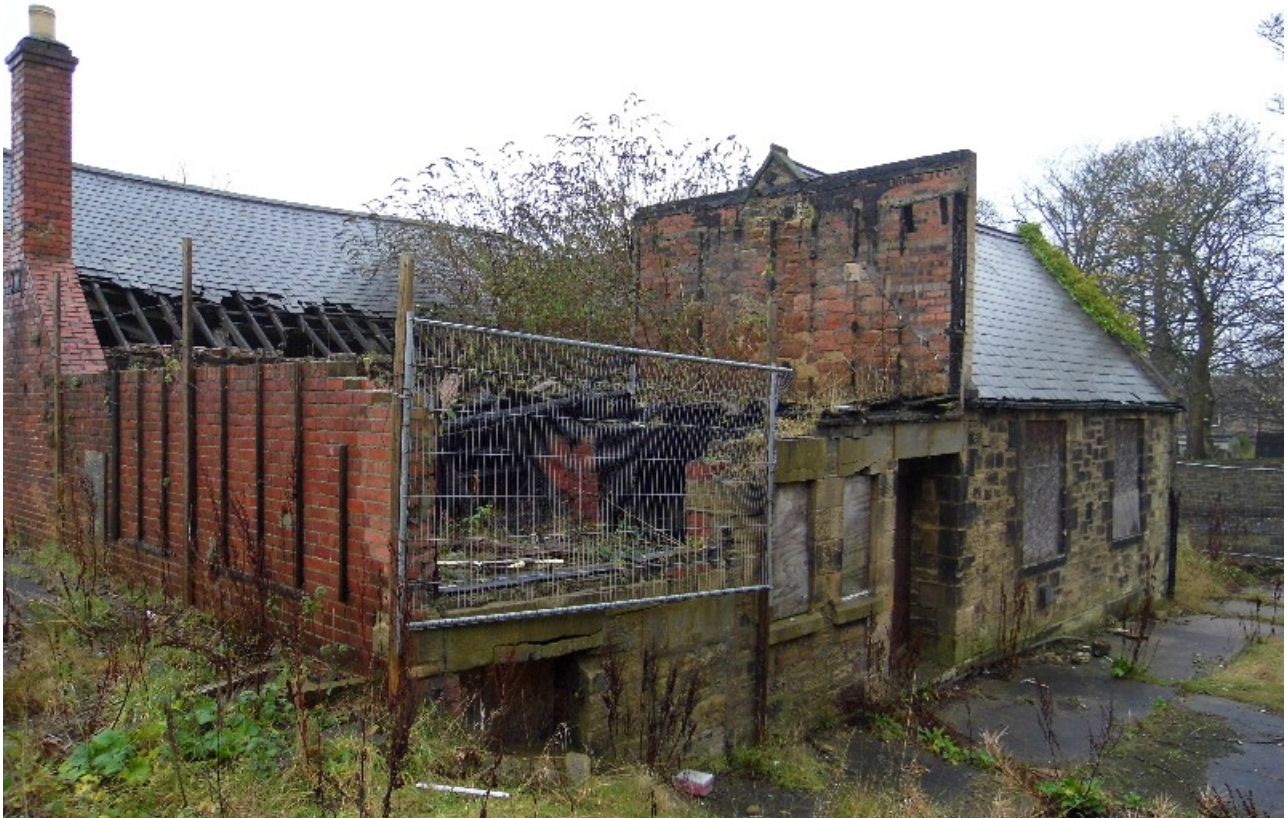
- 3.2.6 The western side of the elevation (*Plate 4*) is badly damaged by fire, though whether through one incident or multiple incidents is uncertain. This block was built in 1932 with a sandstone frontage mimicking the earlier stone phase of construction. The two windows (W20 and W21) are narrow and boarded up, with stone lintels and protruding sills. The doorway (D2) to the storage area is blocked, and it was observed that the area behind this wall was too unstable to enter safely.

Plate 4. The southern elevation of the school from the southwest, showing the damage to the 1932 building phase (frame BOS14005)

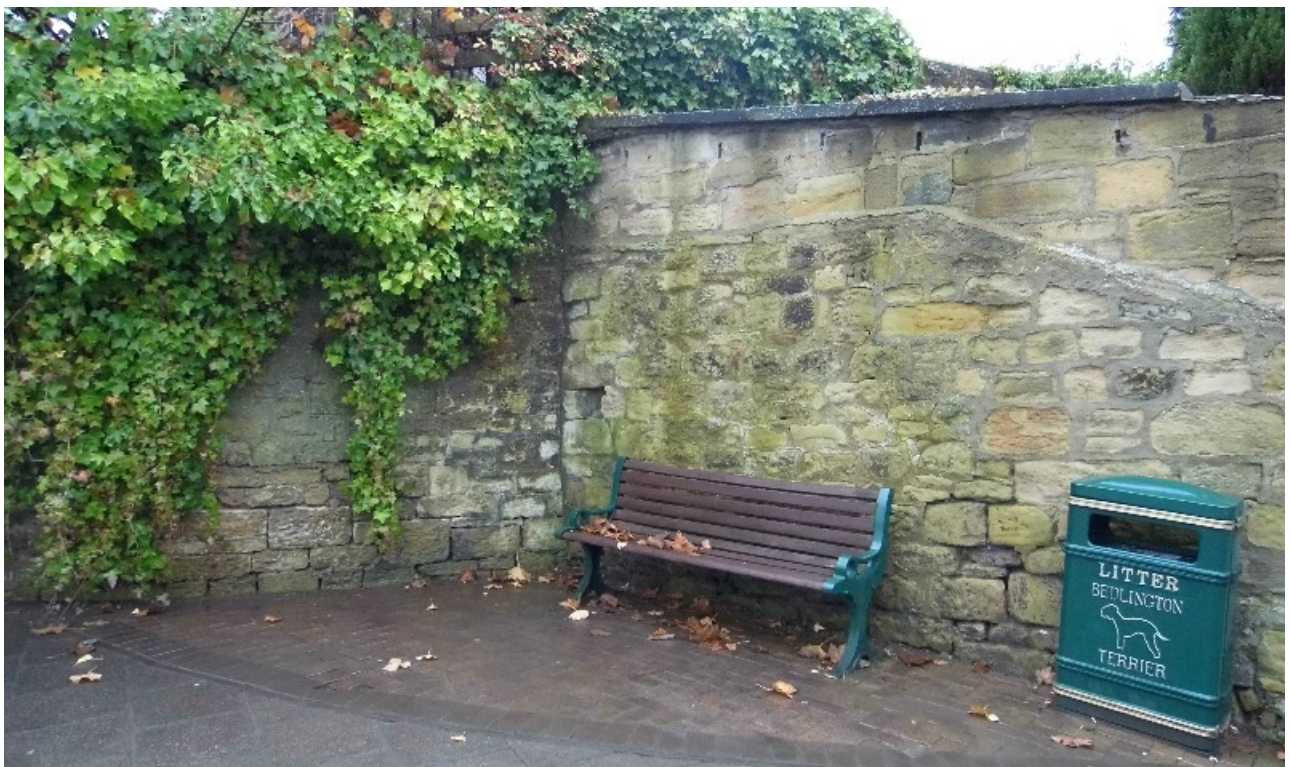
- 3.2.18 **The boundary wall:** Like the majority of walls in this section of Bedlington, the property's boundary wall is built of sandstone rubble. For the most part, the current wall follows the original line of the property boundary shown in the 1865 Ordnance Survey map. However, it has been repaired over the years and added to. Plate 9 (opposite) shows a view of the northeastern corner of the boundary wall, used as a shelter: the layers of repairs and additions are clearly visible.

Plate 9. The northeast corner of the boundary wall, taken looking southwest (frame BOS14018)

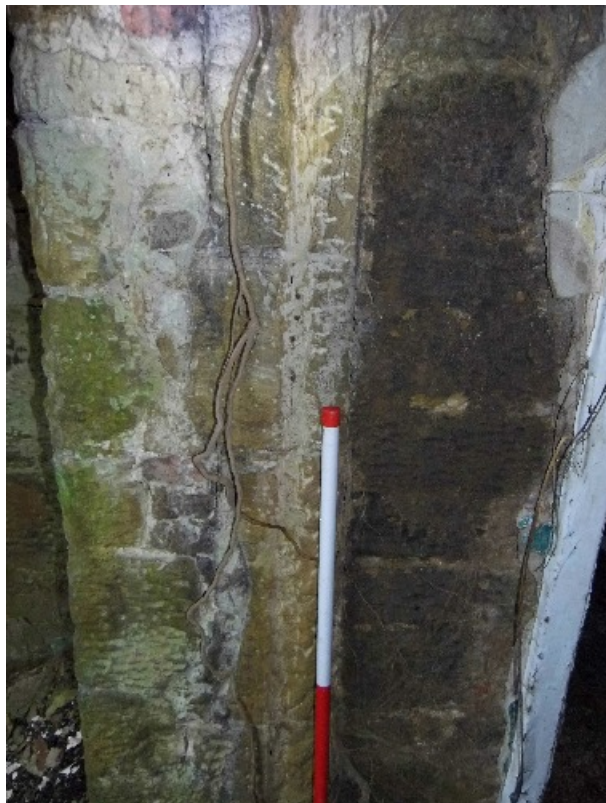
3.3.4 **Area 2 (storage room):** 2.1m x 1.8m. This small storage area was extremely unstable, with a loose damaged overhanging ceiling and floor debris. For health and safety reasons, this room was not entered but simply photographed from doorway D14.

Plate 12. Storage area 2 looking southwest (frame BOS14023)

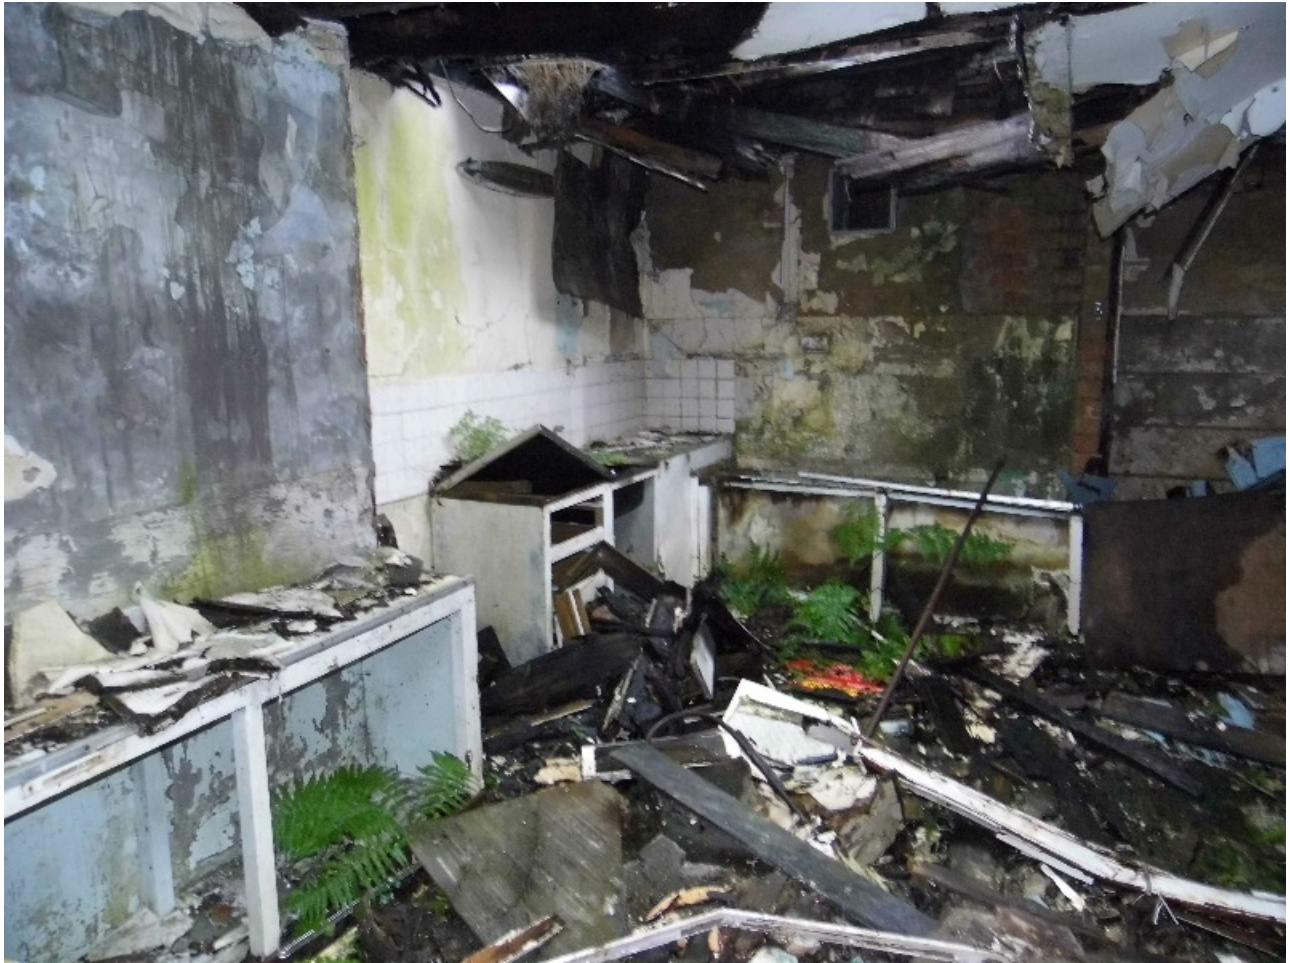
Plate 13. The kitchen (Area 4) looking southwest (frame BOS14026)

- 3.3.8 **Area 4 (kitchen):** 5.1m x 4m. The kitchen was severely damaged by fire (see *Plate 13* above), rendering it too dangerous to enter. The room was photographed from the doorway. The ceiling had mostly collapsed and the floor was strewn with debris, making it impossible to gauge safe footing.

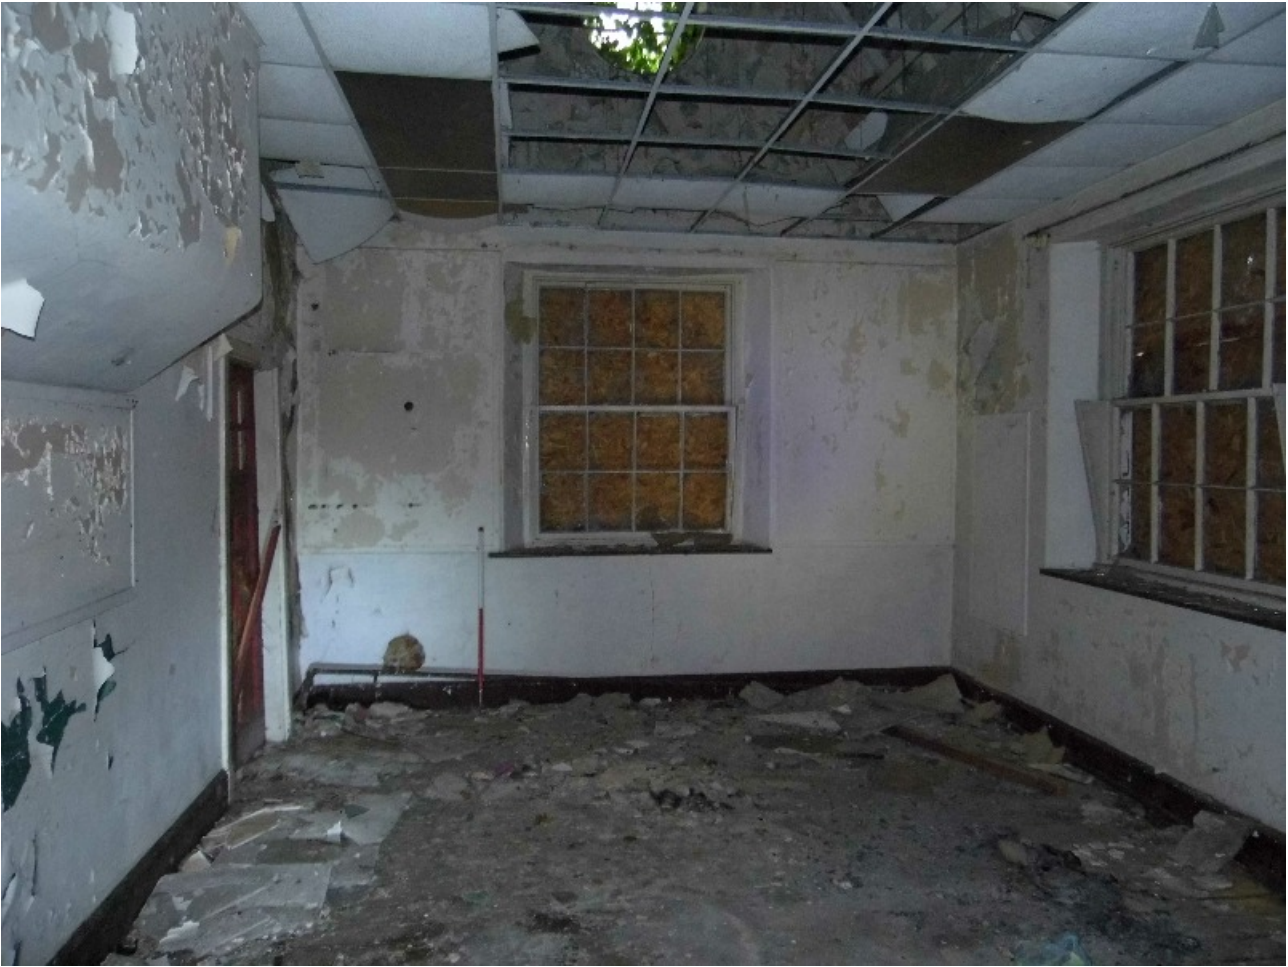
- 3.3.11 The wooden floorboards were rotten and the suspended ceiling was collapsing, making access to the room an issue.

Plate 14. Room 1 (Area 5) looking east (frame BOS14027)

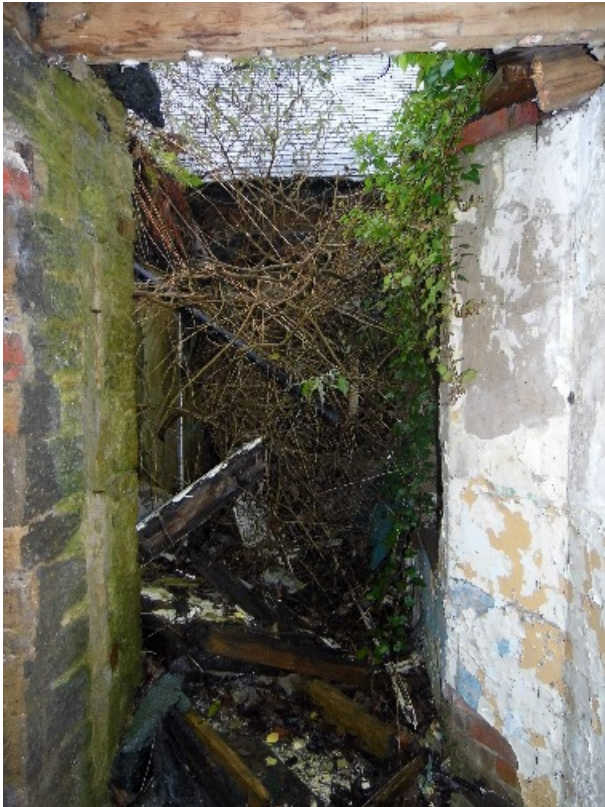
had also grown up through the debris causing further problems (see *Plate 19*). In the northern extent of the lobby is a timber double door, likely to be original to the 1930s build. (See *Plate 20*).

Plate 19. Access through the northern doorway in Area 7 to lobby Area 8 (frame BOS14037)
