Bedlington Old School
Front Street West, Bedlington
Northumberland
NZ 426015 581860

Archaeological Building Recording
for

Dysart Developments Ltd

109-14-HS | December 2014

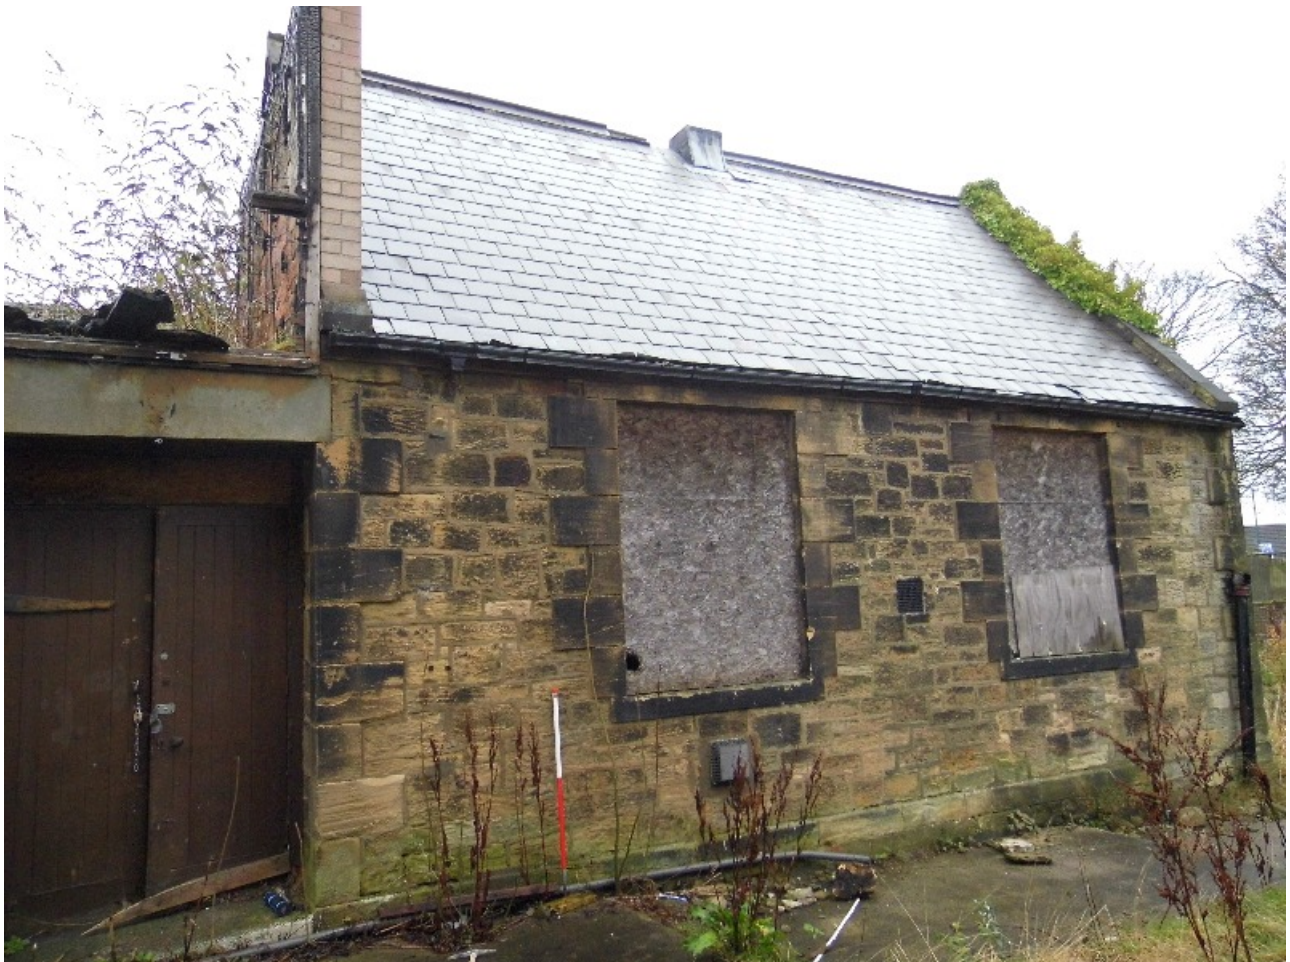
- 3.2.5 The eastern side of the southern elevation (*Plate 3*) contains two windows, now boarded up. Both windows, W1 and W2, have stone sills and lintels with quoined jambs. A shallow stone plinth is also present.

Plate 3. The southern elevation of the school, showing the original phase on the right (frame BOS14004)

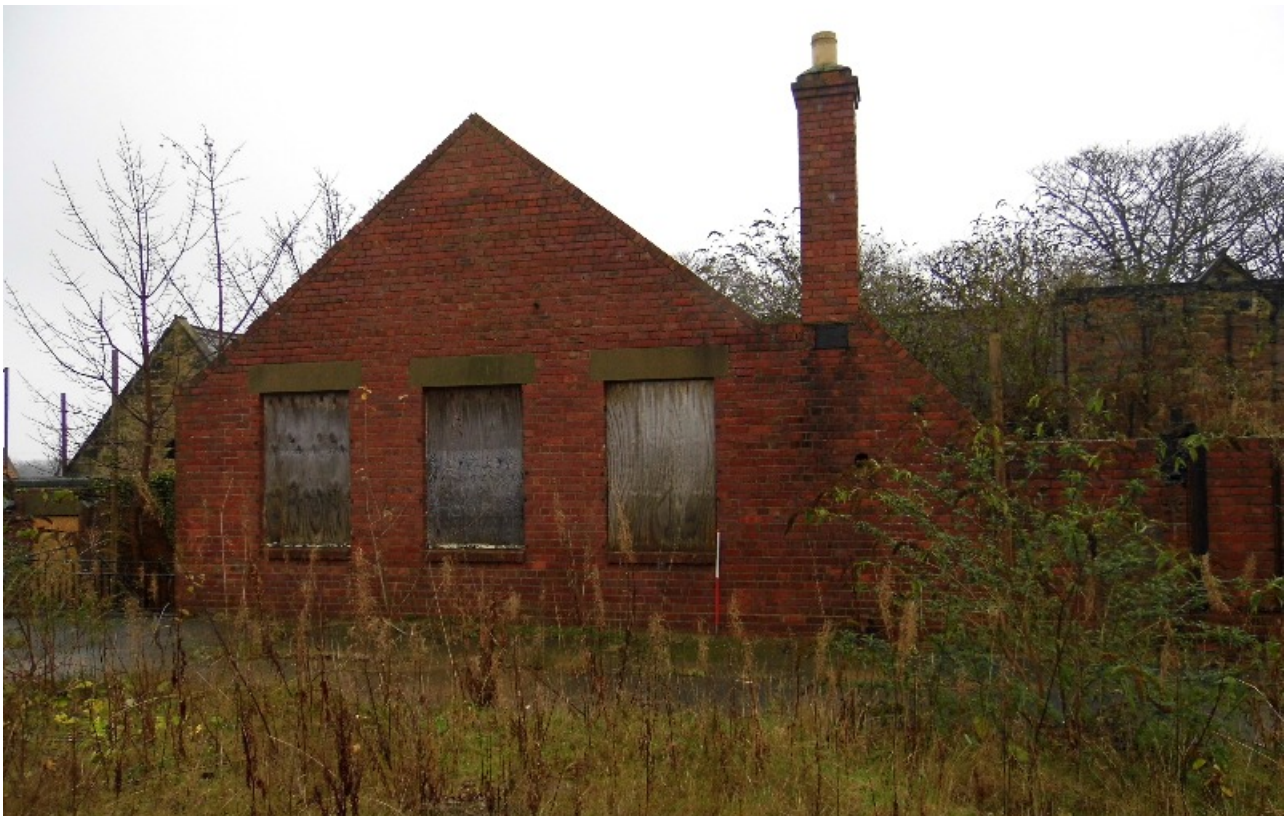
- 3.2.8 **Western elevation:** The western elevation is primarily made up of the 1932 additional build (*Plate 5*), constructed of coursed red brick in English Bond style. The main frontage holds three large windows (W17-19), boarded up, each with a stone lintel and a protruding brick sill.

Plate 5. The western elevation, central section (frame BOS14007)

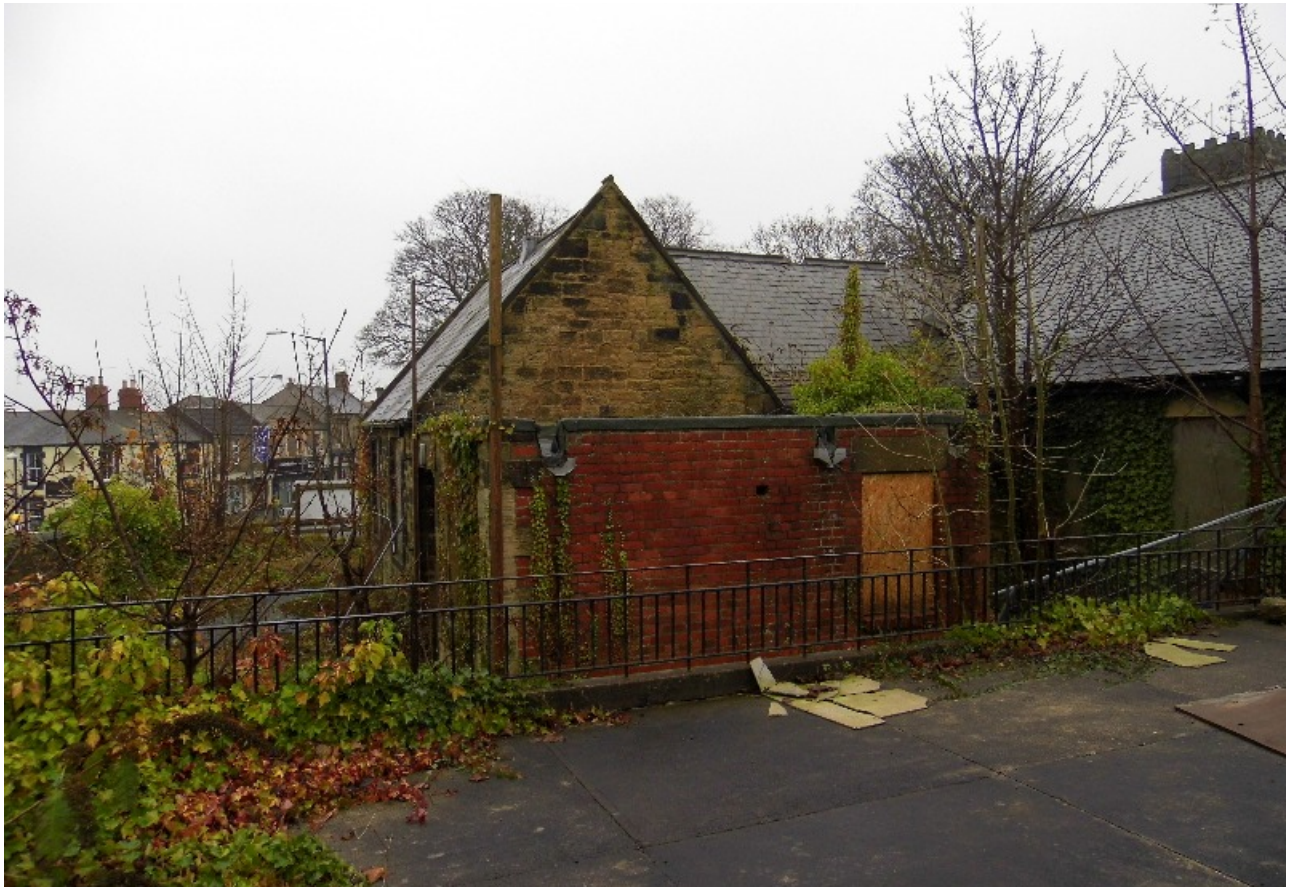
- 3.2.10 In turn, the elevation returns north for a short section of multiple phased wall, with the base of the wall being the original sandstone built and the upper courses being the 1932 brick build. Where the wall breaks west again onto a further 1932 addition, the original stone gable end of the school can be seen *in situ* (Plate 6).

Plate 6. The northern extent of the western elevation showing the original gable in-situ (frame BOS14009)

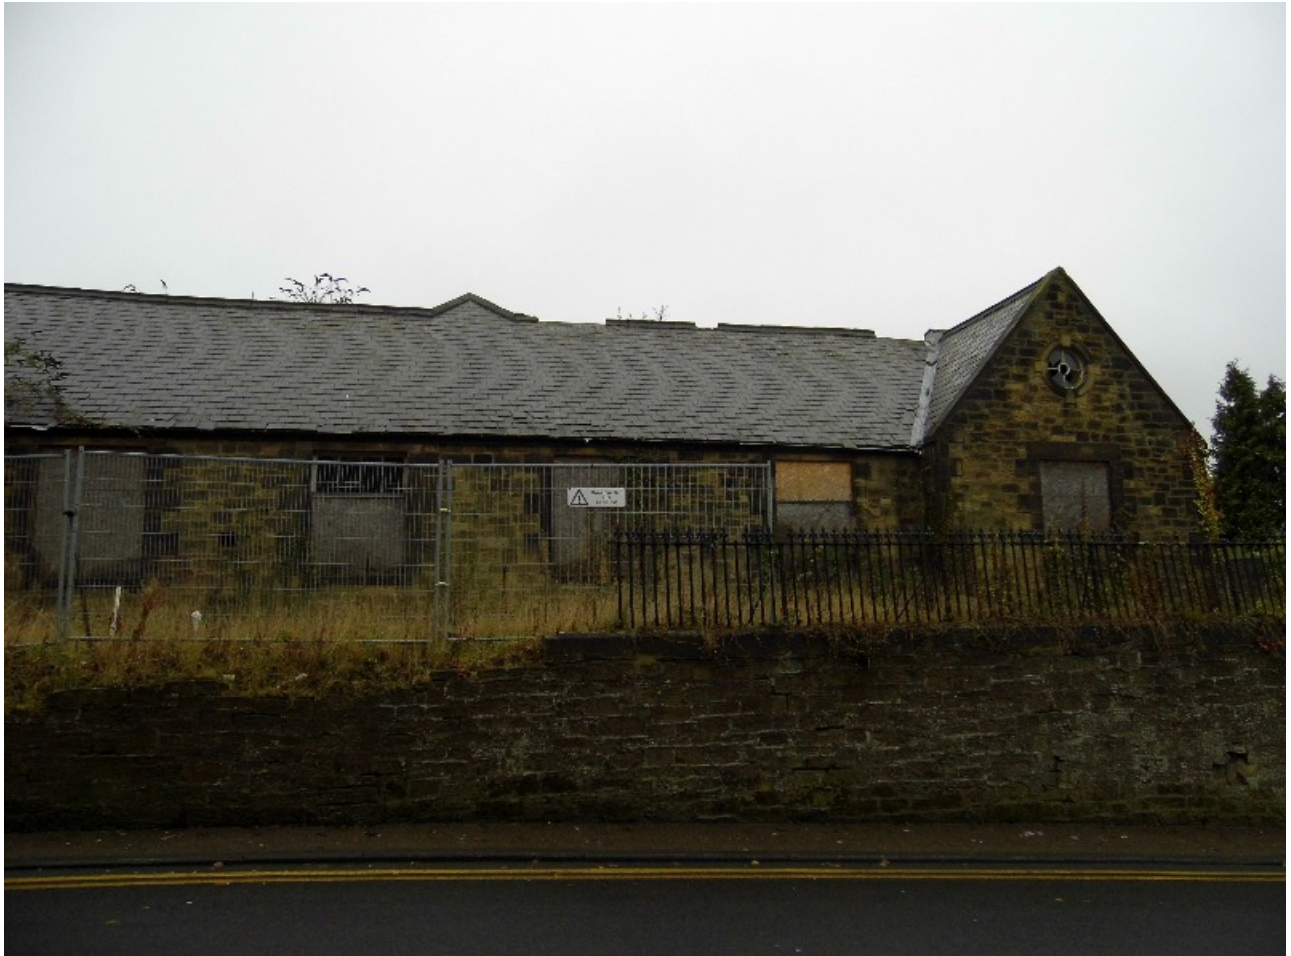
- 3.2.14 An image of the elevation can be seen on *Plate 7* overleaf.
- 3.2.15 **Eastern elevation:** The eastern elevation is the primary elevation viewed from Church Lane, and retains its original phase 1 form. The elevation has two gable ends and holds 6 windows on the ground floor. Each window has a stone lintel, sill and quoined jambs.

- 3.2.16 Each gable end holds a Victorian round leaded window centrally at loftspace height, set in a stone surround with keystones set at each 90° angle. The glass in the northern window is broken, and the southern window (and most of the associated gable) is obscured by a heavy ivy growth.

Plate 8. The eastern elevation from Church Lane (frame BOS14014)

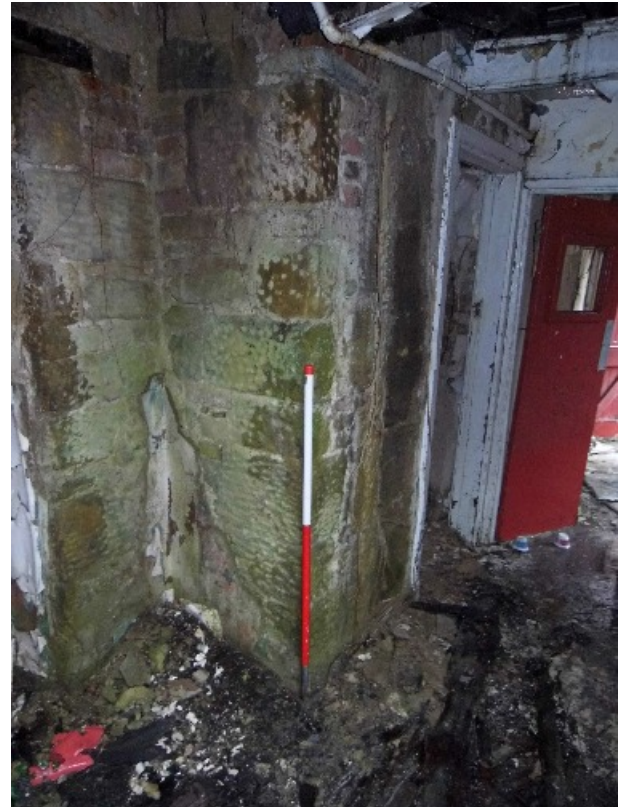
3.3.3 The lobby area is structurally unsound in its ceiling and in debris strewn across the floor. Of interest in this area is the visible stonework that once marked the edge of the original phase 1 school build. Plates 10 and 11 show the area in detail, with Plate 11 providing a close-up view of the original building edge.

Plate 10. View from within the lobby, looking southeast (frame BOS14022)

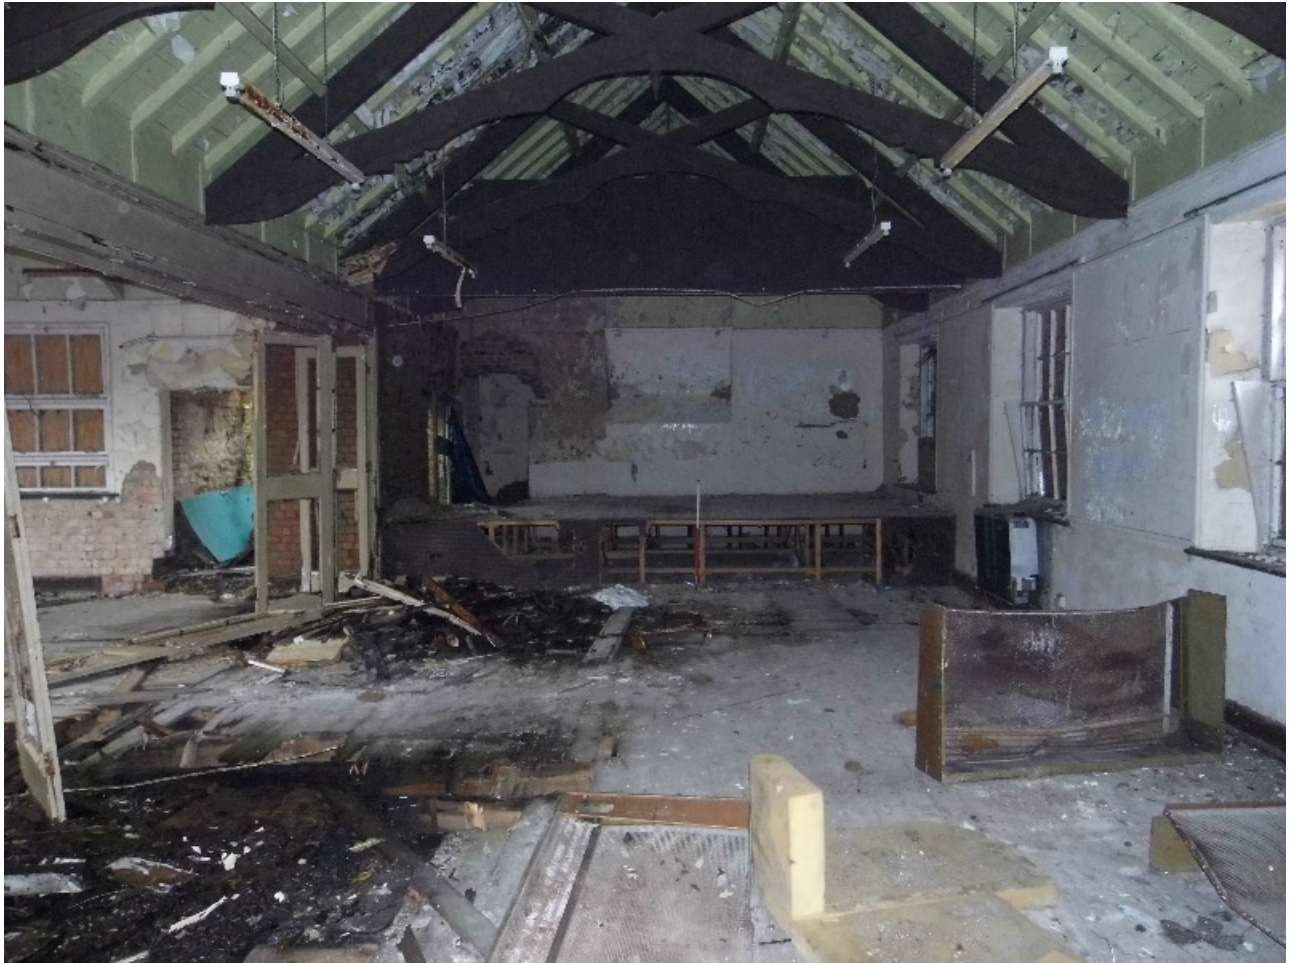
Plate 17. The Assembly Room (Area 6) looking north (frame BOS14031)

- 3.3.12 **Area 6 (Assembly Room):** 15m x 6m. The Assembly room had a number of access issues, with the floor timbers being primarily rotten and in some cases burnt as well as the accessible floor area being strewn with syringe tips and other potential narcotic paraphernalia. The western stud wall that would once have divided the hall from Room 2 (Area 7) was gone, and had been in part used to cover large areas of damaged floor in Area 7.

- 3.3.13 In the south wall were the remains of a blocked chimney, matching that seen on the opposite side of the wall in Area 5: Like the windows in Area 5, the windows in the Assembly Room were 16-light hoppers. In the northern section of the area was the stage (which can be seen in Plate 17 above).

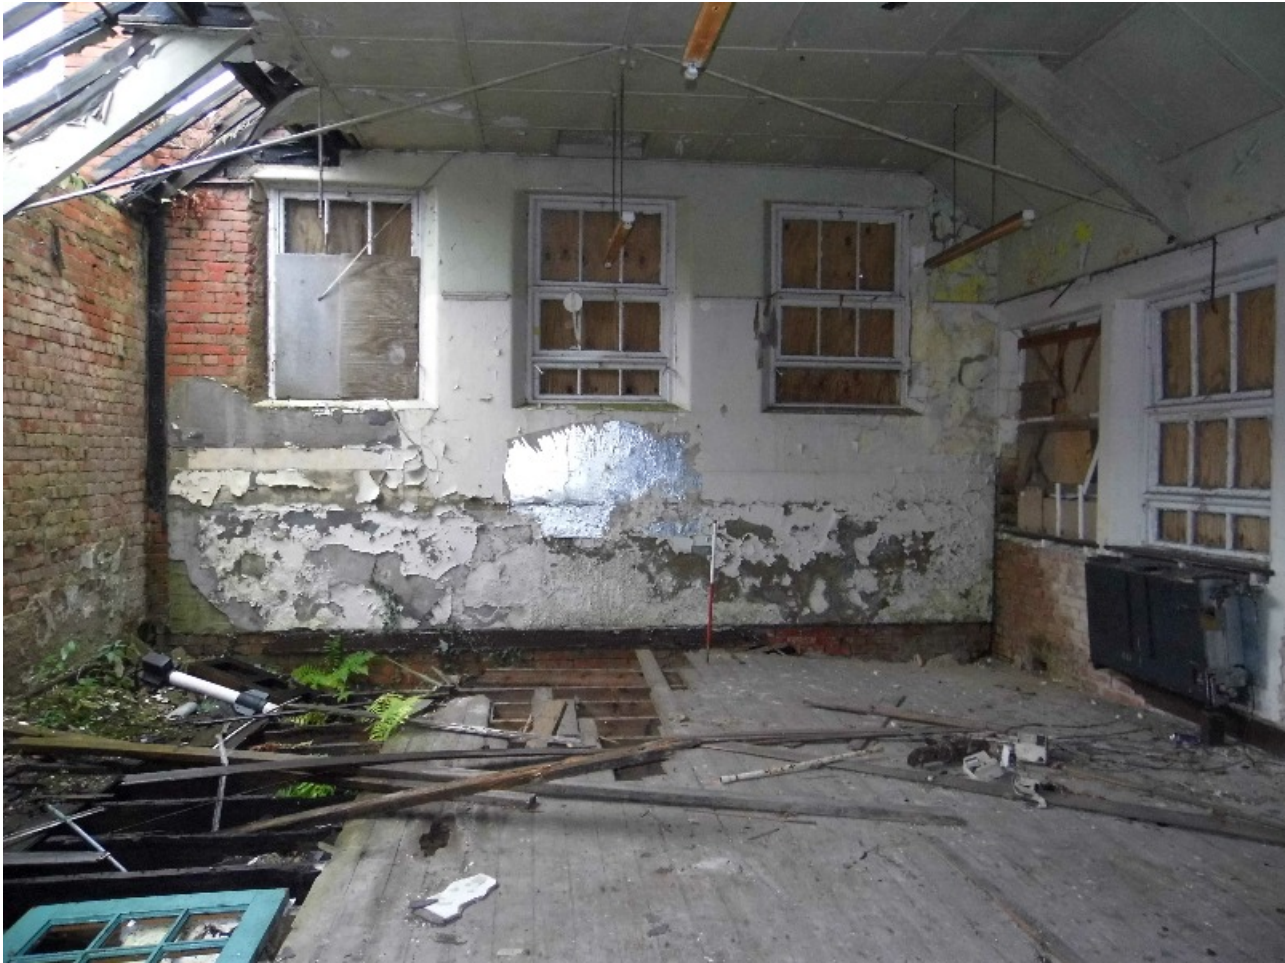
- 3.3.15 This room would have been the primary hall for the original 19th century school build.
- 3.3.16 **Area 7 (Room 2):** 7.8m x 7.7m. Room 2 was added in 1932 and divided by a stud wall from the Assembly Room. Like Area 6, Room 2 had access issues due to the rotten and broken floorboards, coupled in this case by the southern extent of the room having been subject to a fire causing severe roof and ceiling damage.

Plate 18. Room 2 (Area 7) looking west (frame BOS14035)

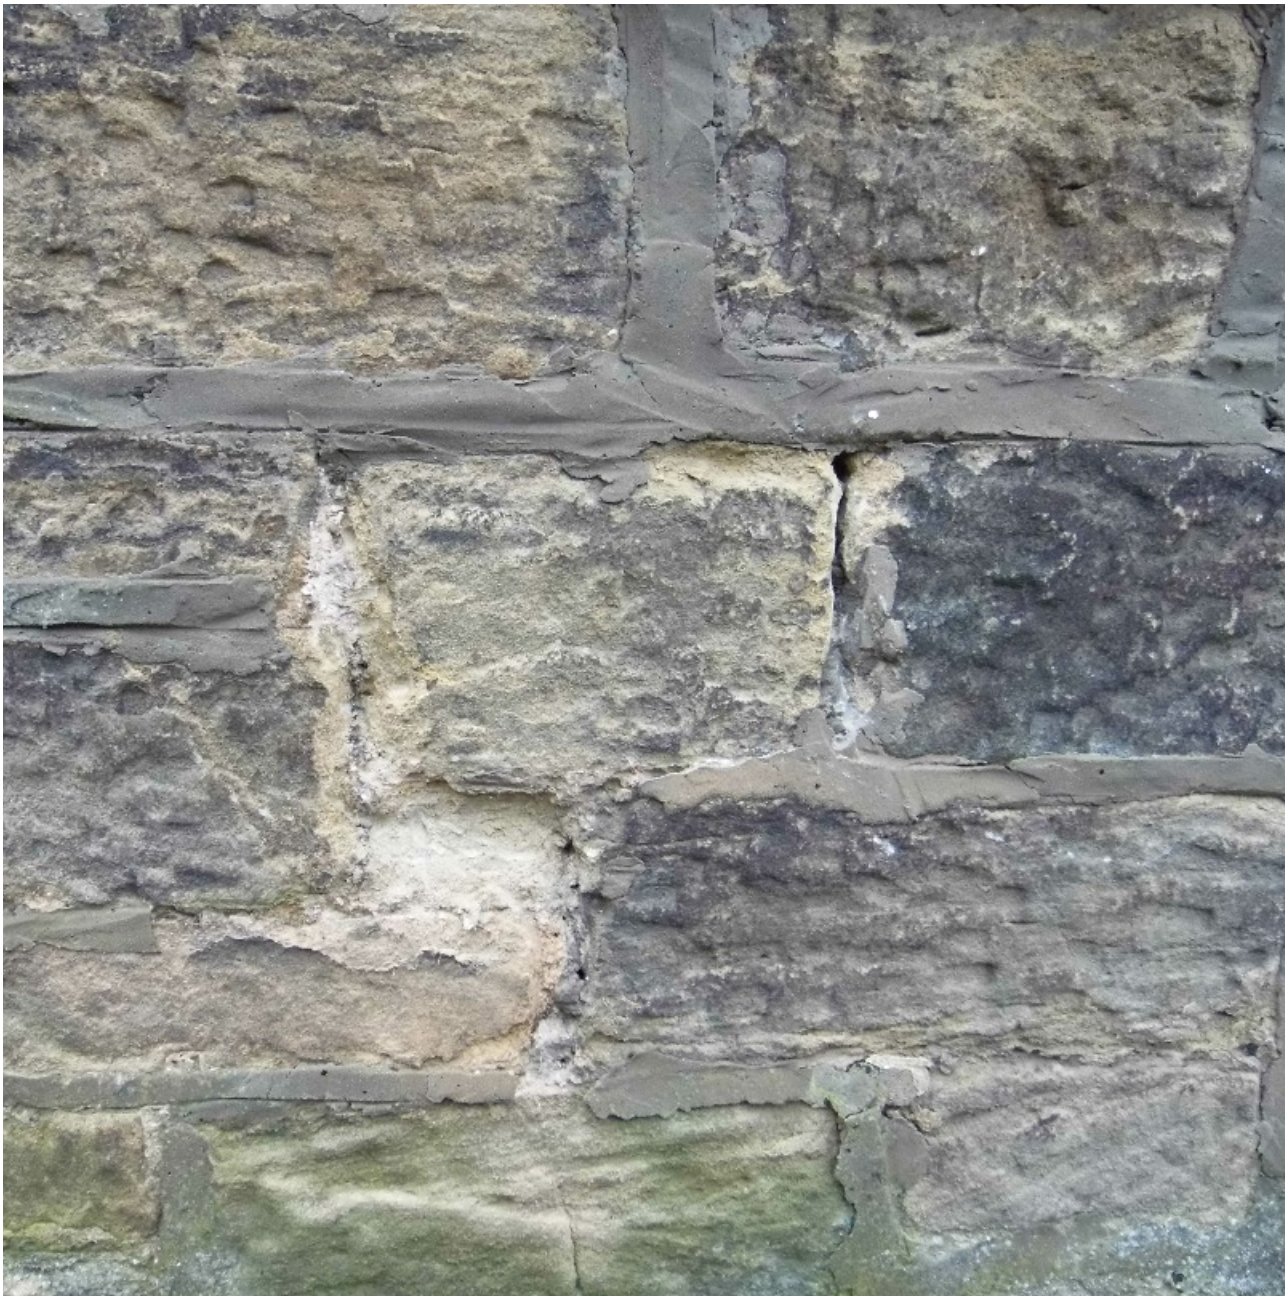
- 3.4.2 Unfortunately this type of stone is commonly used in and around the Bedlington area and almost without exception, buildings made with this stone have issues with both porosity and structural stability.
- 3.4.3 Stone of this type has a problem with moisture and is prone to surface decay or dusting. This problem is increased when it has been pointed in cement as the joints become waterproof and any moisture that is formed is forced to expel from the stone and not the joint (lime pointing would allow the joints to breathe).
- 3.4.4 In conclusion we would not recommend the re-use of this stone in any new build. The only exception to this is the plaque which is built into the south side of the east elevation as this is sandstone of a much higher quality.

Plate 22. An example of the degraded stone on the southern elevation with inappropriate pointing materials (frame BOS14017)

- 4.2.2 **03/00508/CON Condition 3 (Heritage Consolidation Ltd):** Examination of the stone comprising the current school building has suggested that the material is subject to porosity and structural stability issues. It is recommended that the stone is not re-used in the new build, except the stone inscription block on the eastern elevation which is of higher quality than the rest of the material used in the building and thus usable in the new build.
